National Aeronautics and
Space Administration

FA:EC43-78-17
July 7, 1978

FAILURE ANALYSIS
OF
FLASHING LIGHTS
MICRO ELECTRONICS
P/N 209-B SN 7 & 12

ELECTRONIC PARTS VERIFICATION BRANCH
ELECTRONICS DEVELOPMENT DIVISION
ELECTRONICS AND CONTROL LABORATORY

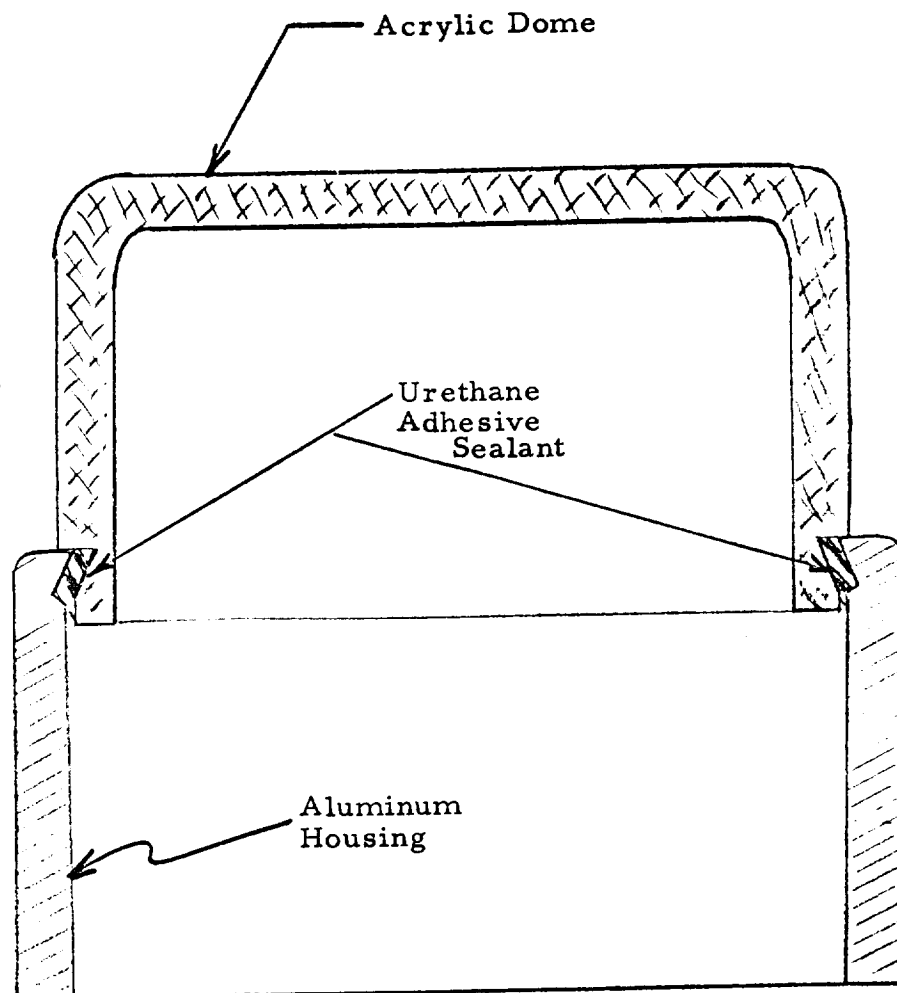
The dome is attached to the aluminum housing with an adhesive as shown in Figure 1. The adhesive material is a polyurethane (Furane X-87718-A/B).

Figure 1: Dome-Housing Assy.

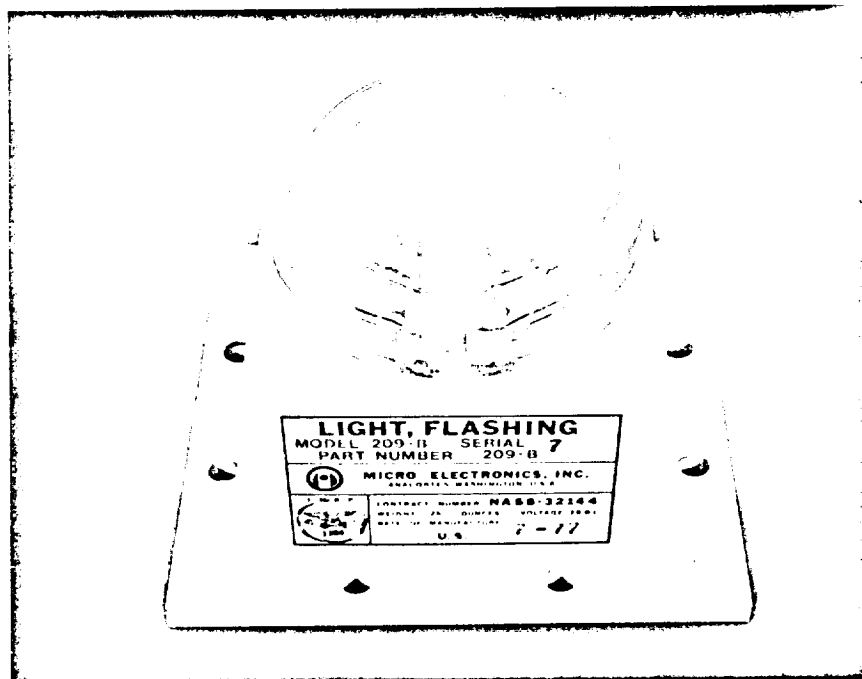
The light assemblies are shown in photographs 1 and 2 and consist of the following:

Photograph No. 1: Flashing Light SN 7

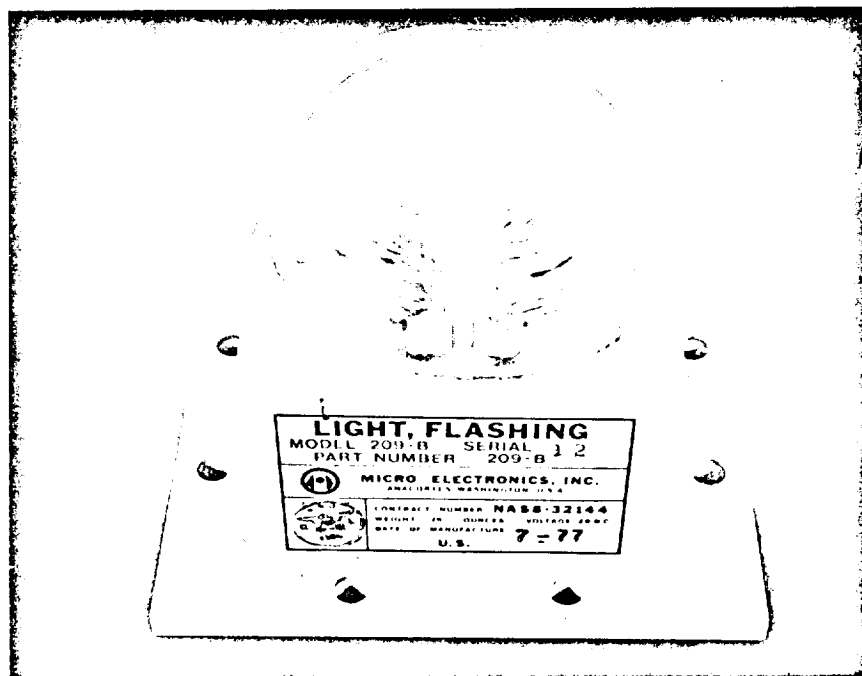
Photograph No. 2: Flashing Light SN 12

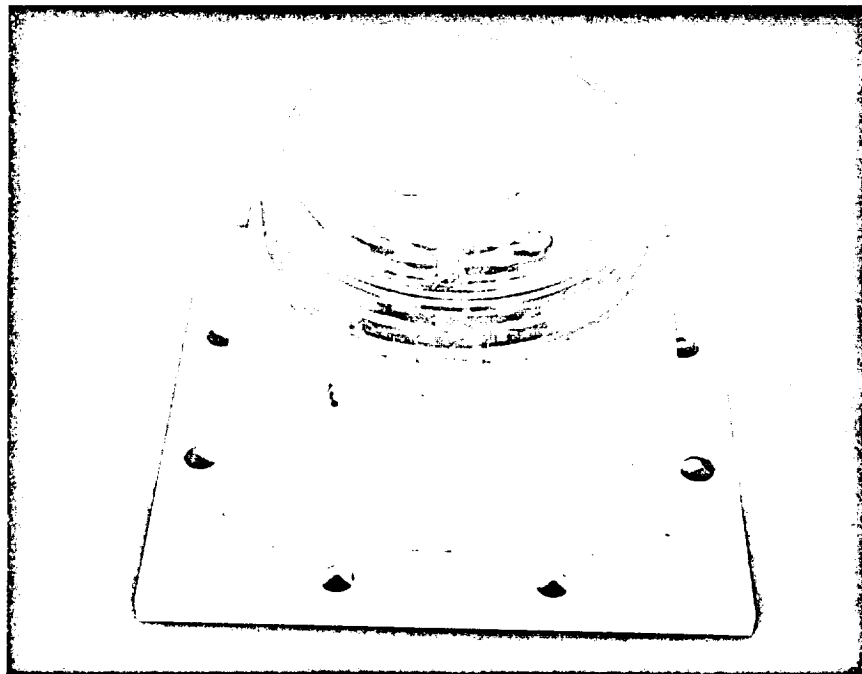
A failure analysis plan (Attachment 1) was developed. Upon receipt of the lights in failure analysis, they were photographed, documented, and subjected to functional tests. SN 7 did not function electrically. SN 12 passed all functional tests. The observed failed conditions are shown in photographs 3 through 8. The dome-to-housing seal was fractured on both units approximately 270° around the circumference. The dome had lifted approximately 1/4 inch from its original position on both lights. The fractured areas were analyzed by the M&P materials specialist. It was determined that the sealant material (polyurethane) had been sheared by stress.

Photograph No. 4: Seal Fracture SN 7

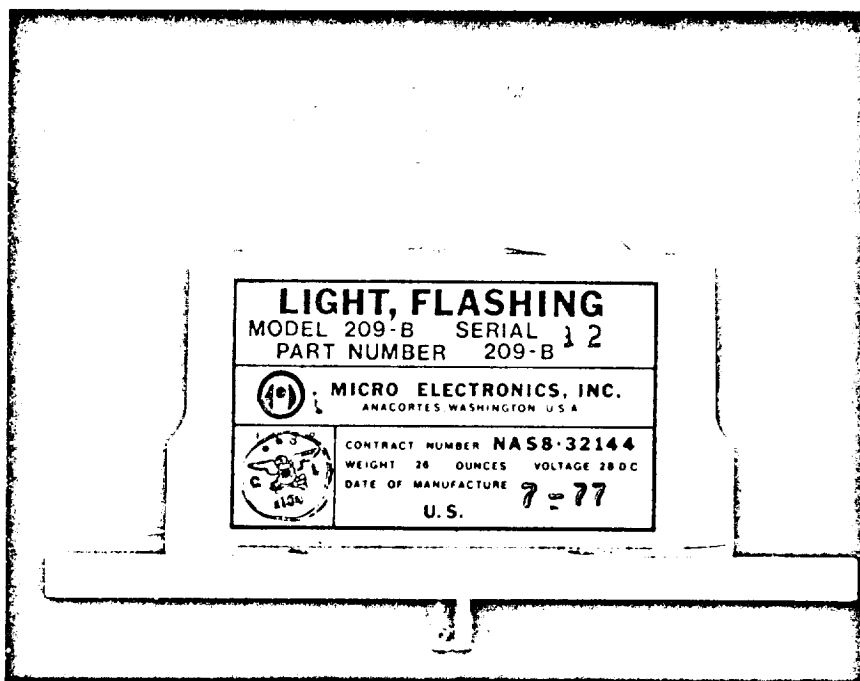
The acrylic dome was removed from SN 12 using the same procedure. A lack of adhesion of the polyurethane to the acrylic was evident. No rupturing of the flash tube or any other anomalies were observed in this unit. The seal fracture was the same as in SN 7.

The relative position of the flash tube electrodes to the fractured seal area accounts for SN 12 flash tube not being ruptured. It can be seen in the photographs that because of the location of the seal fracture in SN 12, the stresses on the electrodes at glass entrance were primarily tensile, whereas in SN 7 these stresses were in bending.

Photograph No. 6: Profile of Seal Fracture SN 12
